PT-SPC1-15P1

1-1/2 HP IRRIGATION PUMP

- Cast Iron Construction
- 115/230 Dual Voltage
- 2 in. Suction, 1-1/2 in. Discharge
- 1-Year Warranty

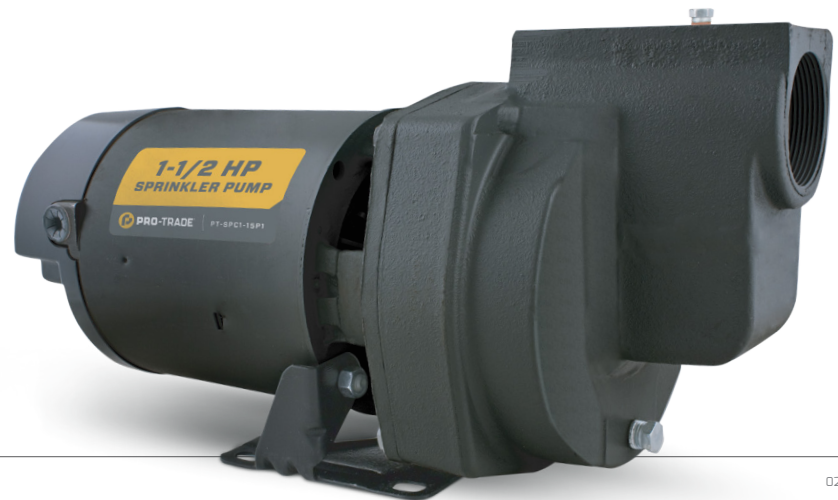
Performance at 10 ft. Lift

Discharge Pressure (PSI)	15	20	30	40 (45 max)
GPM	64	61	52	28

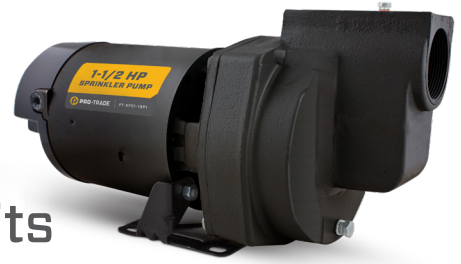
PUMP

- 2" Suction and 1.5" Discharge - (same or better than other popular brands)
- Robust Cast Iron Pump Case - (100 psi)
- Precision Injection Molded Impeller (self manufactured for performance and durability)
- Easy-access drain plug
- 100% Factory Tested - (pump & motor)
- Superior Pressure & Flow Performance (gpm, psi, amps, volts, rotation, in & out of start windings)
- Silicon Carbide Rotary Seal - (Best in the industry)
- 416 SS Threaded shaft (self manufactured)

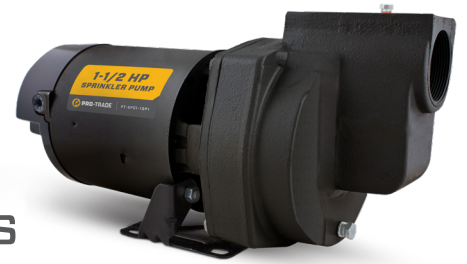
MOTOR

- Zinc Clad Motor Shell - (inhibits corrosion)
- Varnish Dipped Stator Windings - (seals out moisture and reduces vibration) (Hi-potted three times at 2300v)
- Individually Balanced Rotors - (100% to assure smooth, quiet, long life)
- Self-Lubricating SS Ball Bearings - (two, oversized front and rear bearings)
- Superior Cooling Fan - (self manufactured)
- Directional Air-Flow Cooling - (hi-flow air movement through motor housing. Protects switch, governor and capacitor).
- Sealed Switch Assembly - (protection against dust and debris)
- Hi-Service Factor Motor - (1.5 hp motor has a 1.3 SF) ($1.5 \times 1.3 = 1.95$ hp)
- Dual Voltage Motor - (115V or 230V) (FACTORY SET at 230V)

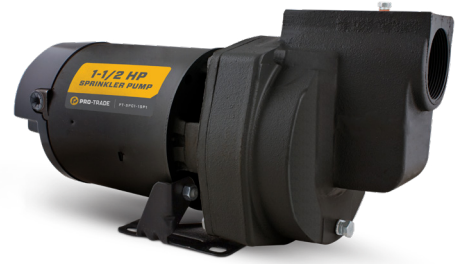
PRO-TRADE™ Performance

*Performance based on CSA Approved Lab Audit Test

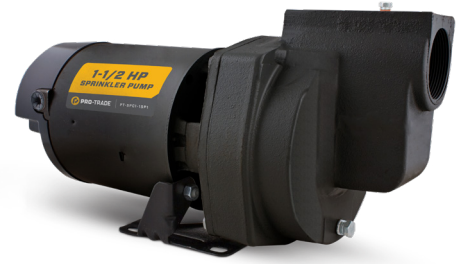
PRO-TRADE™ Comparisons

PRO-TRADE™	BRAND P	BRAND G
Rotary Shaft Seal	Silicon / Carbide	Ceramic / Carbide	Ceramic / Carbide
Suction Size	2"	2"	1.5"
Discharge	1.5"	1.5"	1.5"
Manufacture Motor	YES	NO	NO
100% Factory Tested (Electrical & Hydraulics)	YES	NO	NO

PRO-TRADE™		OTHERS
Yes	65° Ambient Motor Temperature Rise	No
Yes	100 PSI Maximum Case Pressure	No
Yes	Silicon Carbide Shaft Seal	No
Yes	NEMA J 56 Frame Motor	No
Yes	Made in the USA	No

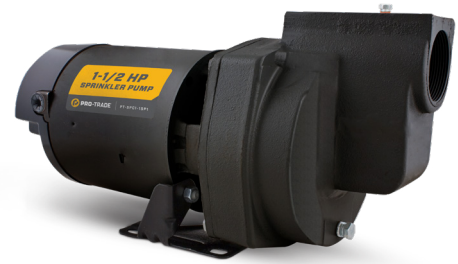
PRO-TRADE™ Troubleshooting

Problem	Possible Cause	Corrective Action
A. Little or no discharge	<ol style="list-style-type: none"> 1. Casing not initially filled with water 2. Vertical lift too high or too long 3. Hole or air leak in inlet line 4. Foot valve too small 5. Foot valve or inlet line not submerged deep enough in water 6. Motor wired incorrectly 7. Inlet or outlet line valves closed 	<ol style="list-style-type: none"> 1. Fill pump casing 2. Move pump closer to water source 3. Repair or replace inlet line. Use thread tape and pipe sealing compound 4. Match foot valve to piping or install one size larger foot valve. 5. Submerge foot valve lower in water 6. Check wiring diagram 7. Open valves

B. Pump will not deliver water or develop pressure	<ol style="list-style-type: none"> 1. No priming water in casing 2. Leak in inlet line 3. Outlet line is closed and priming air has nowhere to go 4. Inlet line (or valve) is closed 5. Foot valve is leaking 6. Inlet screen clogged 	<ol style="list-style-type: none"> 1. Fill pump casing 2. Repair or replace 3. Open ball valve 4. Open line or valve 5. Replace foot valve 6. Clean or replace inlet screen

C. Loss of suction	<ol style="list-style-type: none"> 1. Hole or air leak in inlet line 2. Vertical lift too high 3. Insufficient inlet pressure or suction head 4. Clogged foot valve or strainer 	<ol style="list-style-type: none"> 1. Repair or replace inlet line. Use thread tape and pipe sealing compound 2. Reduce vertical lift, install foot valve and prime 3. Increase inlet pressure by adding more water to tank or increasing back pressure 4. Inspect foot valve and/or strainer for debris and remove

D. Pump vibrates and/or makes excessive noise	<ol style="list-style-type: none"> 1. Mounting plate or foundation not rigid enough 2. Foreign material in pump 3. Impeller damaged 	<ol style="list-style-type: none"> 1. Reinforce plate or foundation 2. Disassemble pump and clean 3. Replace impeller

E. Pump will not start or run	<ol style="list-style-type: none"> 1. Motor wired incorrectly 2. Blown fuse or open circuit breaker 3. Loose or broken wiring 4. Stone or foreign object lodged in impeller 5. Motor overheated 	<ol style="list-style-type: none"> 1. Check wiring diagram 2. Replace fuse or close circuit breaker 3. Tighten connections and replace broken wiring 4. Disassemble pump and remove foreign object 5. Allow unit to cool, restart after cooling

F. Pump loses prime	<ol style="list-style-type: none"> 1. Clogged foot valve or strainer 2. Worn or broken foot valve 3. Hole or air leak in inlet line 	<ol style="list-style-type: none"> 1. Inspect foot valve and/or strainer for debris, and remove. 2. Inspect and replace 3. Repair or replace inlet line. Use thread tape and pipe sealing compound

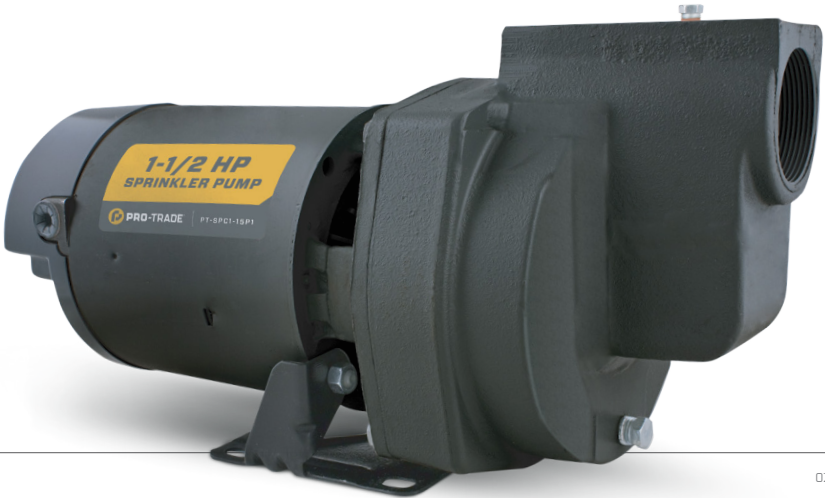
PT-SPC1-15P1

- Cast Iron Construction
- 115/230 Dual Voltage
- 2 in. Suction, 1-1/2 in. Discharge
- 1-Year Warranty

Performance at 10 ft. Lift

Discharge Pressure (PSI)	15	20	30	40 (45 max)
GPM	64	61	52	28
